Factory and fabrication cut-off

CLIO II

19 ECHOING UNDER BODY AT FRONT LEFT-HAND SIDE OF VEHICLE.

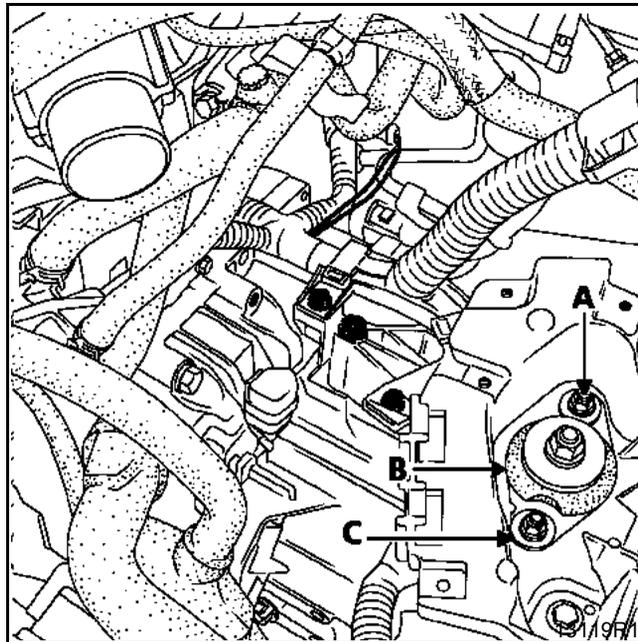
Fig. 1

- Echoing under body at front left-hand of vehicle when driving.

- Gearbox elastic support mountings.

- Replace the two nuts and washers on the gearbox elastic support mounting.

- Disconnect the battery.
- Replace the two nuts and the two washers.
- Tighten the nuts to a torque of 21 Nm.
- Refit the battery.
- Reinitialize the components which were deprogrammed when the battery was disconnected before returning the vehicle to the customer.
