CLIO II

THE VEHICLE WILL NOT START

Cancels and replaces Technical Note no. 3380A from FEBRUARY 2000

Title: Tightness of engine interconnection unit.

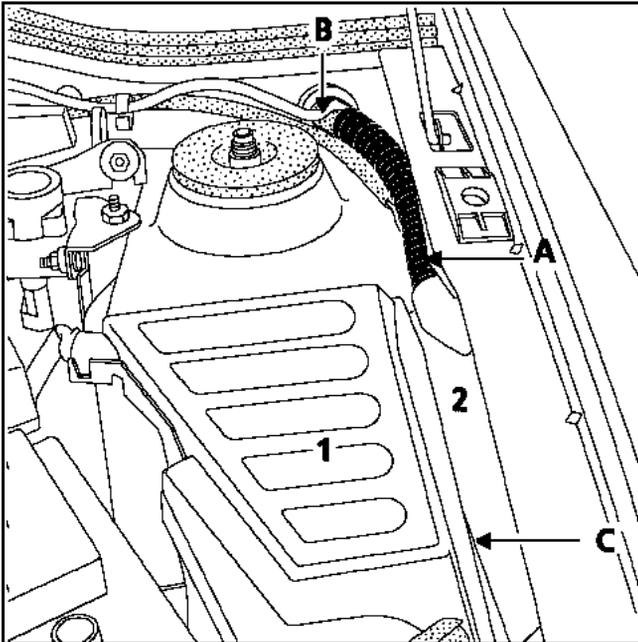
Fig. 1

- Corrosion of connectors or injection relays located in the engine interconnection unit caused by water ingress.

- A - Grooved sheath (L=160 mm)
- B - Code and inertia switch wiring
- C - Cover closure areas (1) and (2) to be checked

- 1 Repair or replace the corroded relay connector.
- 2 Fit a 23 mm diameter grooved sheath, 160 mm in length (A) (Fig. 1). This sheath should be fitted tight against the fuel cut-off switch wiring (B) (Fig. 1) with the slot facing downwards. Surround the sheath with adhesive tape along its length, starting from the fuel cut-off switch wiring.

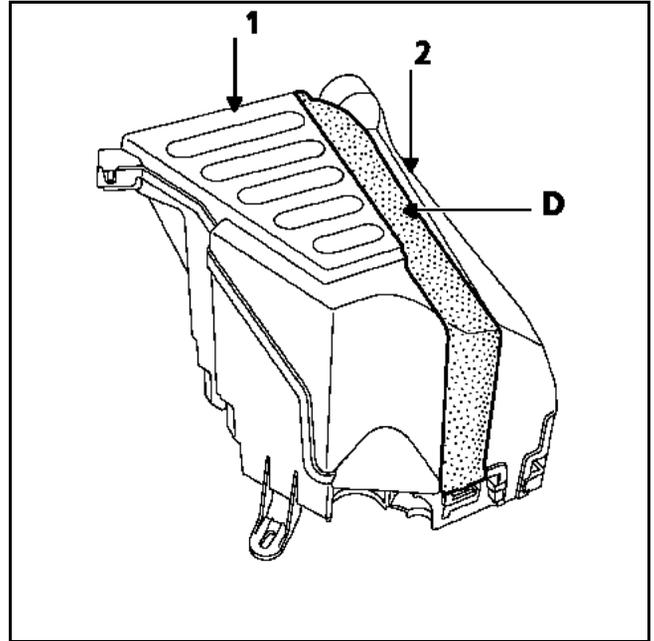
Fig. 2

- D - Adhesive tape

- 3 Check the engine interconnection unit sealing ring. Affix a strip of adhesive tape, Part number: 77 01 051 685, (D) (Fig. 2) to the cover closure areas (1) and (2) (Fig. 2).
