CLIO II

XB0 X

88 CONDITION OF INSTRUMENT PANEL WIRING: HELP WITH FAULT FINDING

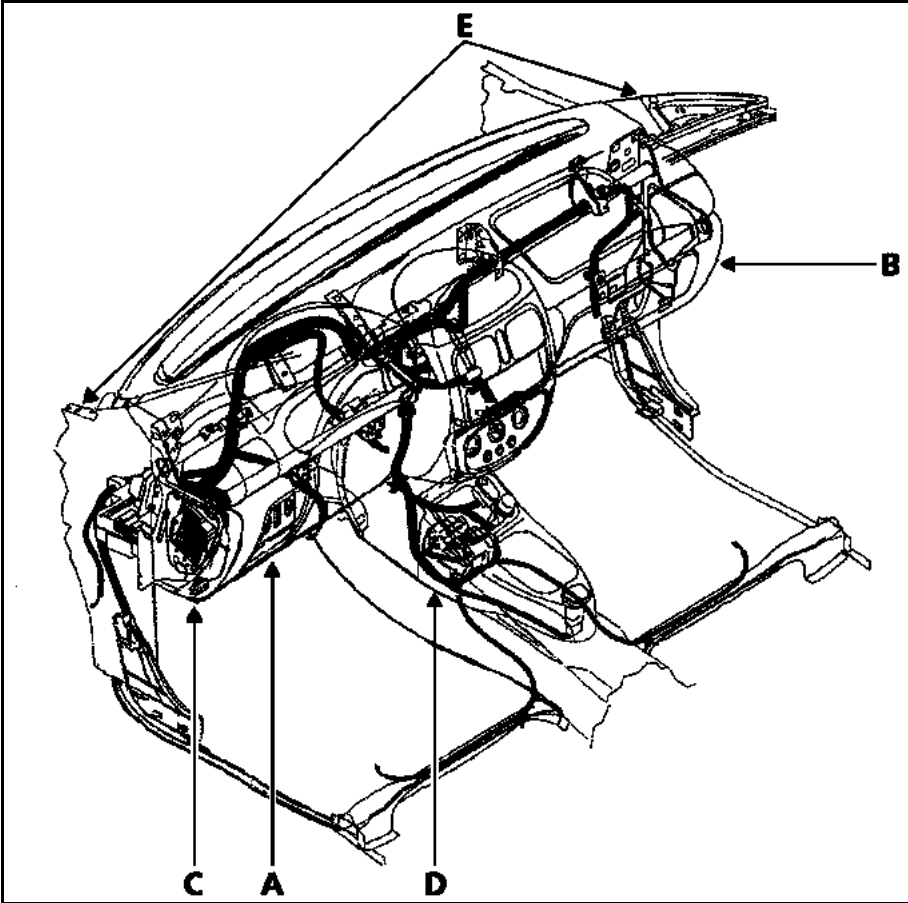
Fig. 1

CUSTOMER COMPLAINT	POSSIBLE CAUSE	OPERATIONS TO BE CARRIED OUT
Fuel level indicator remains at zero.	Instrument panel wiring touching the: <ul style="list-style-type: none">– steering column mounting at (A) (Fig. 1),– instrument panel casing retaining bracket on the right-hand side at (B) (Fig. 1).	Test the wiring at (A) and (B) (Fig. 1) with repair or replacement if necessary. NOTE: protect the wiring in the contact zone
Malfunction of the centralised door locking function and the WARNING function (with brief illumination of the door opening indicator light).	Instrument panel wiring touching the: <ul style="list-style-type: none">– clutch pedal area at (C) (Fig. 1),– "OBD2" (On Board Diagnostic) socket mounting at (D) (Fig. 1).	Test the wiring with repair or replacement if necessary. 1) Attach the wiring to the air pipe using strap clips to prevent this from coming into contact with the clutch pedal. 2) Remove the "OBD2" (On Board Diagnostic) socket mounting burrs. NOTE: protect the wiring in the contact zone

Absence of radio noise on the tweeters.	Instrument panel wiring touching the tweeters and the instrument panel casing at (E) (Fig. 1).	Test the wiring with repair or replacement if necessary. Reposition the tweeter wires to prevent any feedback. NOTE: protect the wiring in the contact zone

- A - Contact area on the steering column mounting
- B - Contact area on the front right-hand casing retaining bracket
- C - Contact area on the clutch pedal
- D - Contact area on the "OBD2" socket mounting
- E - Contact area on the tweeters wires
