CLIO 2

fitted with F4R 730 engine

18A ENGINE OIL CAP ACCESS FLAP LOST OR VIBRATING

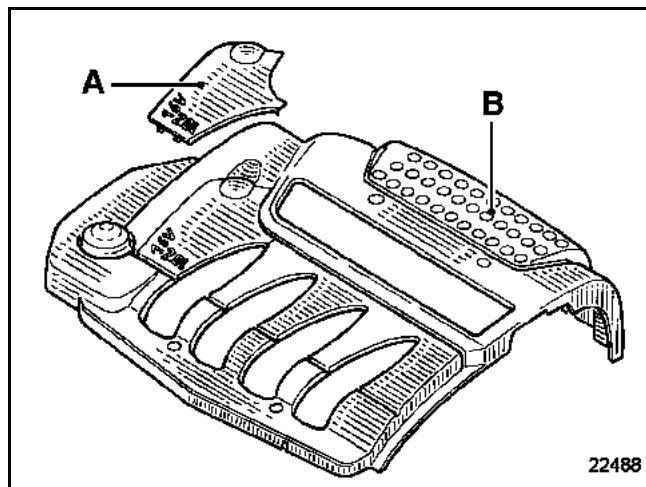
Fig. 1

– Closure of the oil filler cap access flap located on the engine cover.

A - Engine oil filler access flap

- Replace the engine oil filler access flap (A) (**Fig. 1**).

Note: This operation avoids replacing the whole cover.
