CLIO 2 MÉGANE SCÉNIC

17B MOTORIZED THROTTLE BODY CONNECTOR
OTS: **0A4Z** MARK.: **G1**

Motorized throttle body connector

- Replace motorized throttle body connector.
- Reprogram the injection computer.

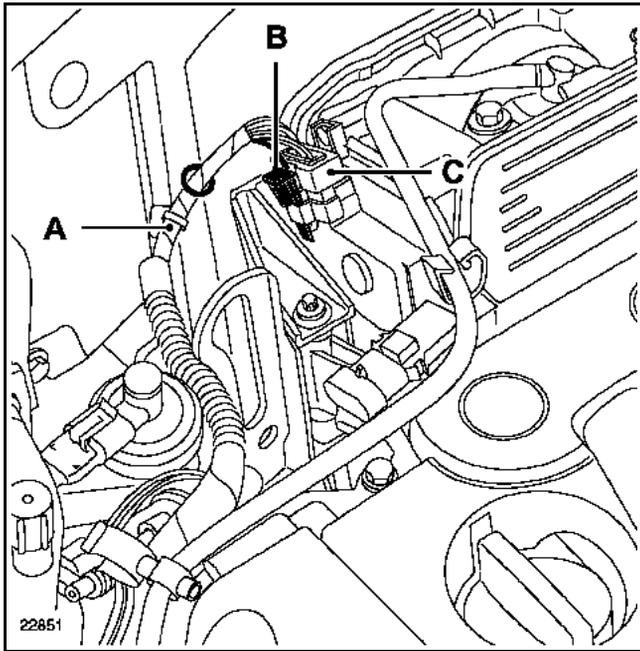
Fig. 1

- A – Retaining clip
- B – Yellow position lock
- C – Motorized throttle body connector

- Disconnect the battery.
- Remove the retaining clip from the electric wiring harness of the motorized throttle body (A) (**Fig. 1**).
- Remove the yellow position lock (B) (**Fig. 1**) if it is present.
- Disconnect the motorized throttle body connector (C) (**Fig. 1**).

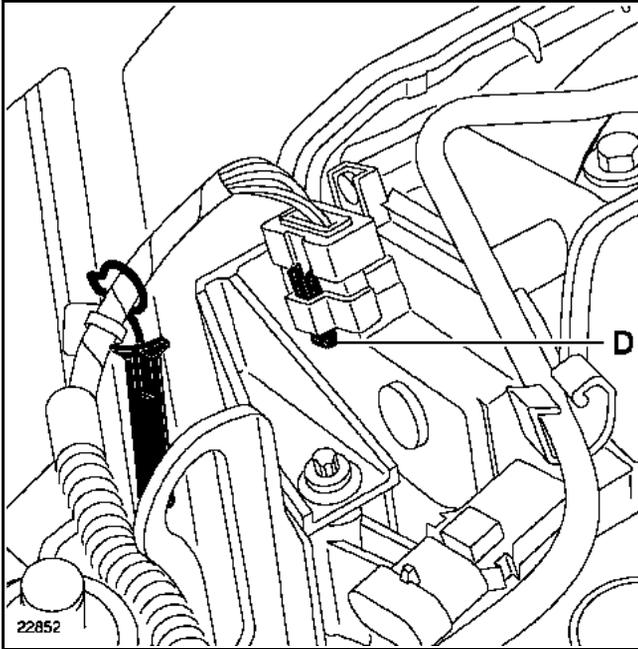
Fig. 2

D – Locking lug

- Confirm locking by pressing on the connector locking lug (D) (**Fig. 2**):
 - If the connector is positioned correctly, pressure puts it in contact with the motorized throttle body.
 - If the connector is incorrectly positioned, the locking lug (D) (**Fig. 2**) is jammed against the throttle body locking tab. If this is the case, disconnect the connector and then reconnect (check that the seal is correctly positioned).
- Attach the yellow position lock (B) (**Fig. 1**) to the connector.
- Tighten the retaining clip strap in such a way as to support the wiring harness.
- Reconnect the battery.
- Reset all the components which lost their AVC feed when disconnecting the battery (radio, clock etc.).
- Reprogramme the injection computer (see next page).
- With diagnostic tool, clear the injection faults present.
- Carry out a roadtest.
