Clio II

62 NEW VERSION OF PASSENGER COMPARTMENT FAN SPEED RESISTOR UNIT

- Engine: **XXX**
 - Gearbox: **XXX**
- Basic manual: M.R. 337**

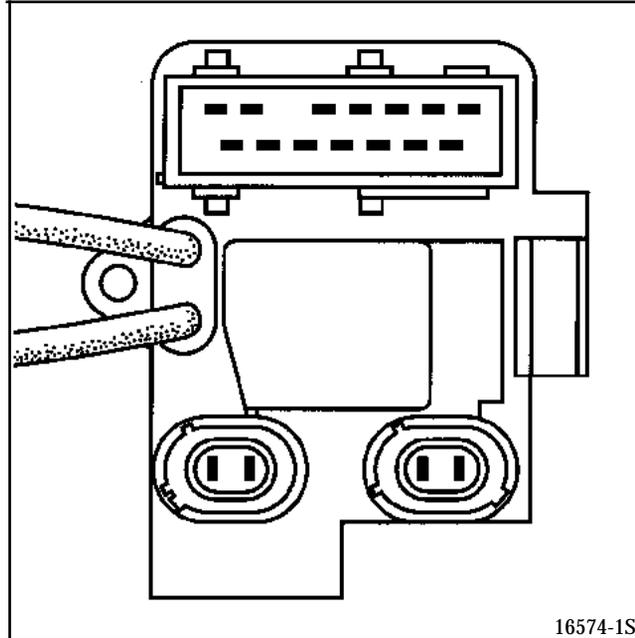
Resistor unit with evaporator sensor as fitted until
15 June 1998.

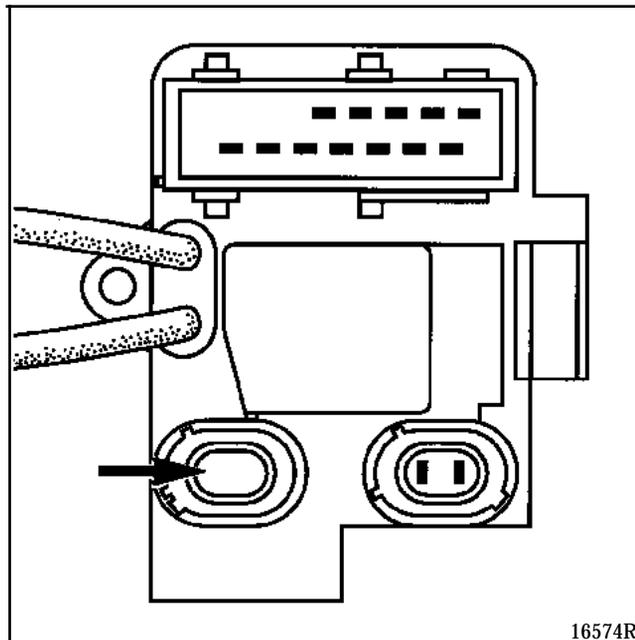
Resistor unit without the evaporator sensor
connector for air conditioning, as fitted in vehicles
after 15 June 1999.

The new computer management system no longer recognises evaporator sensor information for the air conditioning system.

If any work is carried out which requires the replacement of the resistor unit on vehicles which left the factory before 15 June 1998, the computer needs to be reprogrammed.

Connect the diagnostic equipment.

NXR	XR25
Select dialogue mode with the computer. "Computer configuration" command. "Configuration without evaporator sensor" command, line 4912 (evaporator sensor).	Enter code D17 to select the mode to communicate with the computer. Enter code G49*12* for the configuration "without the evaporator sensor" (evaporator sensor).
