KANGOO CLIO II

36 WHINING FROM POWER ASSISTED STEERING WHEN MANOEUVRING

STEERING ASSEMBLY

Power assisted steering pump assembly

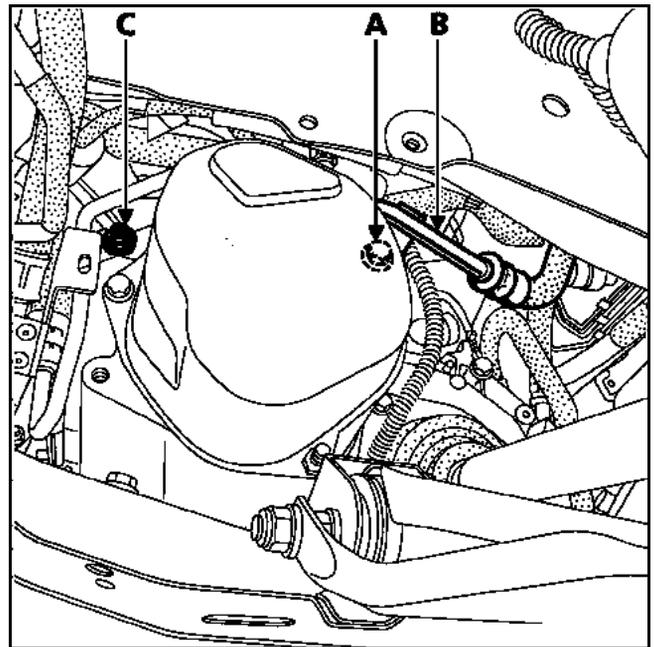
Fig. 1

- A – Stud
- B – High pressure pipe
- C – Bolt

- Disconnect the battery.
- Remove:
 - the left hand front wheel,
 - the mudguard.
- Disconnect the pump assembly connector.
- Remove:
 - the earth strap on the gearbox,
 - the pump assembly pipes.
- Fit:
 - low pressure pipe **part no.: 82 00 033 764** on the original mounting points without connecting it to the pump assembly bottle,
 - stud **part no.: 77 03 027 328** instead of the upper bolt (A) (**Fig. 1**) on the 5th gear gearbox housing.

- Fit high pressure pipe (B) (**Fig. 1**) by attaching it to the stud (A) (**Fig. 1**) using nut **part no.: 77 03 033 025**, and using the bolt (C) (**Fig. 1**) **part no.: 77 03 002 072**.
- Connect the low pressure pipe to the pump assembly bottle.
- Adjust the power assisted steering circuit.
- Refit the assembly in the reverse order to removal.
- Reinitialize the components which were deprogrammed following disconnection of the battery before returning the vehicle to the customer (Clock, Radio Code).
