### fitted with JB/JC gearbox

#### 21 GEAR SELECTION IMPOSSIBLE - OIL LEAK FROM THE GEARBOX

- Manual: **JB/JC**
- Technical Note: **3483A**

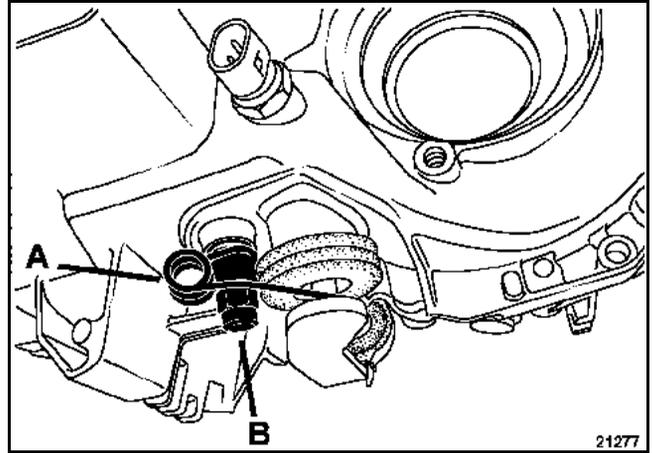
Fig. 1

- Displacement of the gearbox selector shaft seal.

- On a lift drain the gearbox.
- Remove the return spring (A) (**Fig. 1**) and the point of resistance of 5<sup>th</sup> gear (B) (**Fig. 1**).
- Slide the dust seal gaiter (C) along the selector shaft (D) (**Fig. 2**).
- Remove the selector shaft seal (E) from its housing (F) and allow the oil to flow along the selector shaft (D) (**Fig. 2**) for 2 hours.
- Degrease the selector shaft seal (E), the selector shaft (D) and the seal housing (F) (**Fig. 2**) with a cleaner (for example **Part no.: 77 11 171 911**).
