CLIO II

37 ACCELERATOR CABLE (RIGHT-HAND DRIVE VEHICLES)

OTS: 0A2M MARK : F1

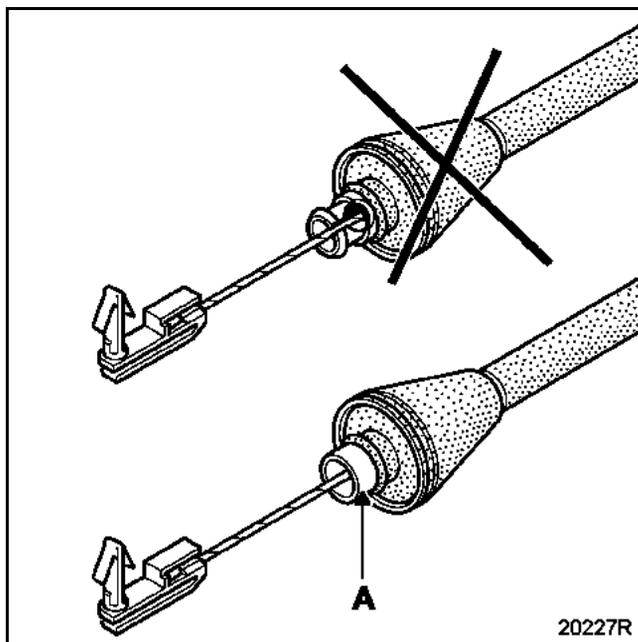
Fig. 1

A - New sleeve end piece

- Replace the accelerator cable with a new accelerator cable (A) (Fig. 1).
