**KANGOO
CLIO II
MEGANE
SCENIC
TRAFIC**

fitted with F8Q engine

*Cancels and replaces Technical Note No. 2921A dated FEBRUARY 1998
Modifications: Extension of vehicles concerned*

13 ENGINE KNOCKING DURING TORQUE PICKUP, DIFFICULT TO START FROM COLD

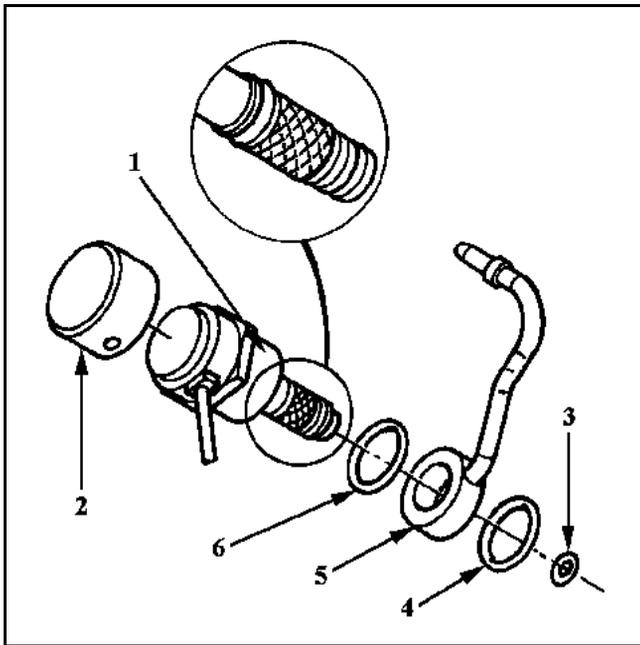
Fig. 1

- Bonding of injection pump feed actuator core.

- 1 - Supply actuator
- 2 - Plastic cover
- 3 - Gauze filter
- 4 - Banjo gasket
- 5 - Return banjo
- 6 - Actuator gasket

- Unclip the wiring harness from the actuator connector.
To do this:
 - a) remove the yellow protective plate from the connector using a small hook (eg.: **FACOM 1195 2**).
 - b) separate the two tabs on either side of each pin then pull each wire. Actuator wires: pins **2** and **7**.
- Remove:
 - sheath,
 - advance actuator (1) (**Fig. 1**).
- The small filter (3) at the base of the socket (**Fig. 1**) **must** be removed using a clean pair of needle-nose pliers to avoid introducing any foreign bodies into the pump.
- Replace the filter with a new gauze filter from the set.
Note: The outer part serves as a seal and is destroyed when the actuator is tightened to torque.
- Replace in order:
 - a) the return banjo gasket (4) (**Fig. 1**) and the actuator gasket (6) (**Fig. 1**),
 - b) the new actuator (1) (**Fig. 1**) with new gauze.

- Tighten the actuator to a torque of **4.5 daNm** using socket **Mot. 997-01**.
- Fit the new cover (2) (**Fig. 1**) on the actuator, reconnect the connector and fit the protective plate.
- Bleed the diesel circuit using the priming pump before starting the engine.
