# CLIO II

## 19 WHINING BETWEEN 50 AND 80 MPH (80 AND 120 KM/H)

- Engine: **F8Q 630**
- Gearbox: **JB1**

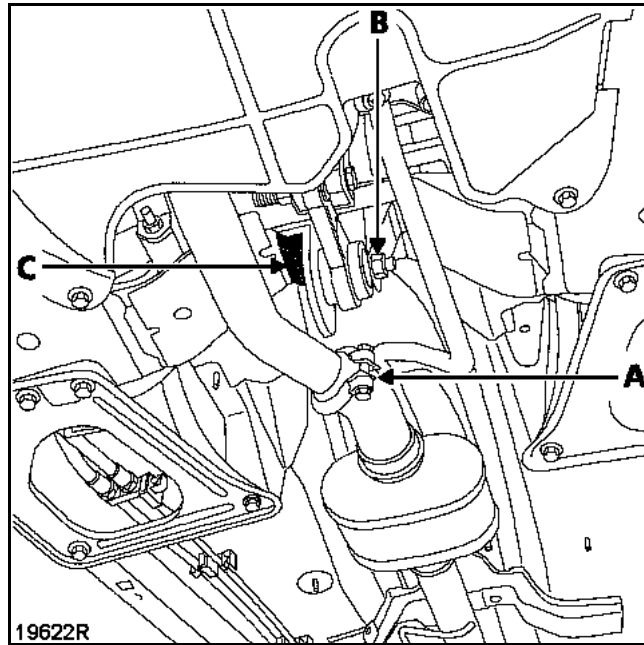
**Fig. 1**

- Whining modulated in 3<sup>rd</sup>, 4<sup>th</sup>, 5<sup>th</sup> and between 50 and 80 mph.

- Increase in noise from the gearbox.

- Fitting a damper (acoustic mass) on the engine tie-bar.

- Put the vehicle on a lift.
- Release the exhaust clamp on the oxidation catcher (A) (**Fig. 1**).
- Remove the engine tie-bar mounting bolt (B) (**Fig. 1**).
- Fit the damper (C) (**Fig. 1**).
- Refit using the same procedure as for removal in reverse.
