CLIO 2 RS

Cancels and replaces Technical Note No. 4296A dated NOVEMBER 2002.

10A ACCESSORIES BELT SLIPS OFF: ENGINE NOISE AND WARNING LIGHT COMES ON

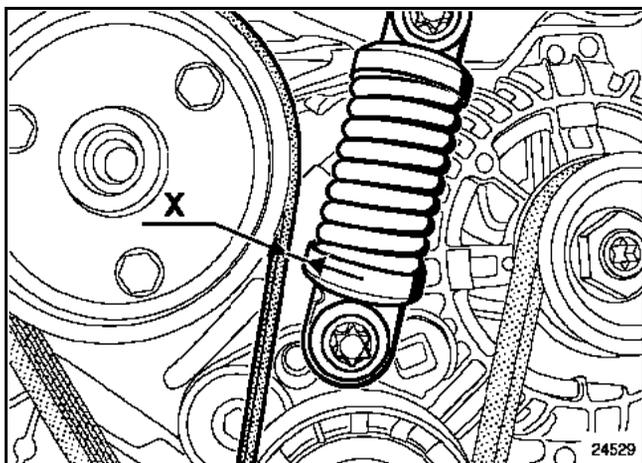
- Use a set of feeler gauges to measure gap (X) between the accessories belt and the adjustable tensioner body.

Gap (X) between the accessories belt and the adjustable tensioner body **MUST** be at least **3 mm**. If gap (X) is smaller than **3 mm**: fit a new accessories belt and check again.

X – Gap value at least **3 mm**

- Replace:
 - the accessories belt,
 - the adjustable tensioner,
 - the air conditioning compressor mounting,
 - the air conditioning compressor,
 - the power assisted steering pump if the part number is different to **82 00 234 212**.
