CLIO 2

Cancels and replaces Technical Note no. 809A dated July 2001
Modifications: replacement parts.

80B WATER IN THE FRONT FOG LIGHTS

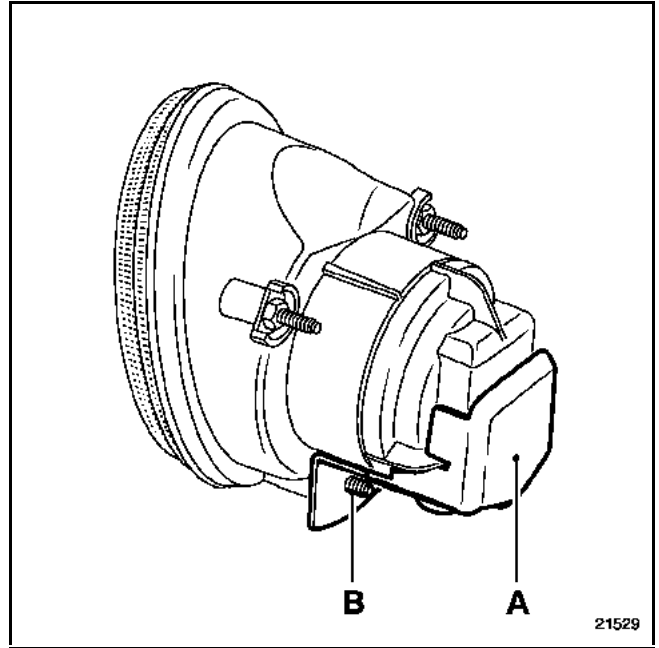
Fig. 1

A – Fog light cover mask

B – Fog light lower mounting bolt

- Put the vehicle on a two-post lift.
- Remove the front bumper.
- Replace the fog light wiring.
- Attach the fog light cover masks (A) (**Fig. 1**) using the fog light lower mounting bolt (B) (**Fig. 1**).
- Refit the front bumper.
- Adjust the fog lights.
